ariane 5

С  
h  
r  
o  
n  
i  
c  
e  
o  
f  
a  
F  
a  
i  
r  
c  
r  
e

## ***Introduction - Abstract***

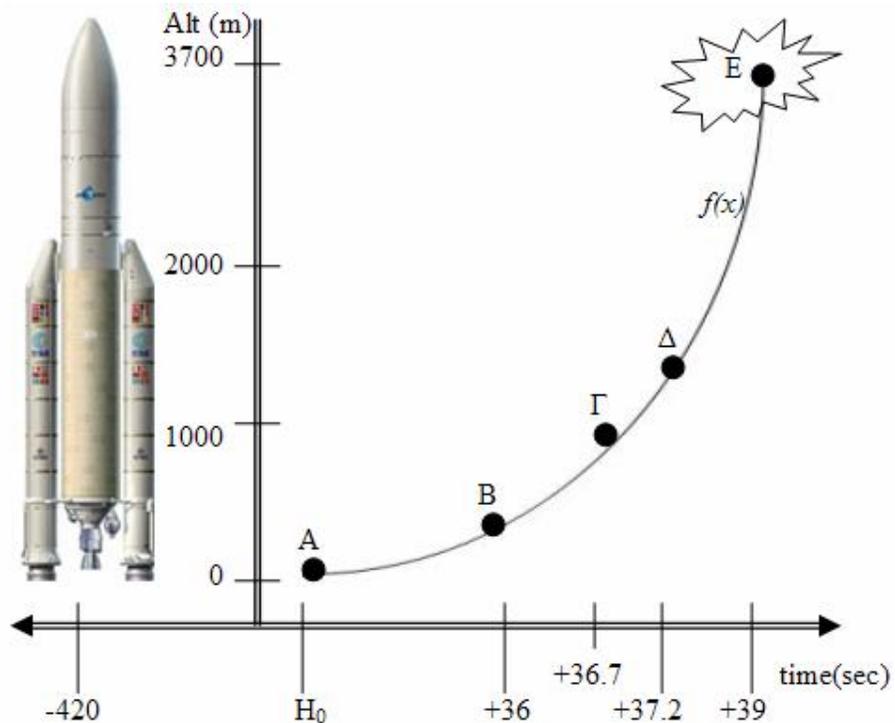
Explaining the above diagram we can see clearly that at the  $H_0 - 7$  minutes (-420 seconds) point the rocket was placed successfully to the launch pad. In basic terms these are the five stages that the rocket was until the explosion.

A) In altitude zero meters and the time  $H_0$  the launch sequence has started and after 9 second we had a successful lift off.

B) A nominal behaviour of the rocket until that time.

Γ) Failure of the back-up inertial reference system followed immediately by failure of the active inertial reference system.

Δ) Swiveling into the extreme position of the nozzles of the two solid boosters and slightly later, of the Vulcain engine, causing the launcher to veer abruptly.

E) Self – destruction of the launcher correctly triggered by rupture of the links between the solid boosters and the core stage (Altitude 3700m.).

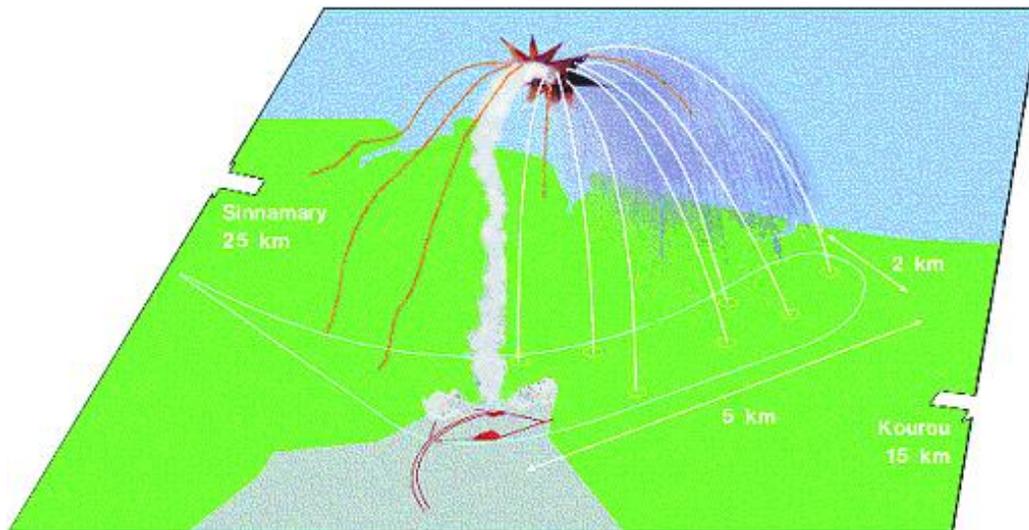
Fragment fallout zone (Source: CNES/CSG)

The debris was spread over an area of 5 x 2.5 km<sup>2</sup>. Amongst the equipment recovered were the two inertial reference systems which have been used for analysis of the disaster.

All the launcher debris fell back onto the ground, scattered over an area of approximately 12 km<sup>2</sup> east of the launch pad. The recovery of the debris was proven a difficult task for the agency since nearly all mangrove swamp or savannah.

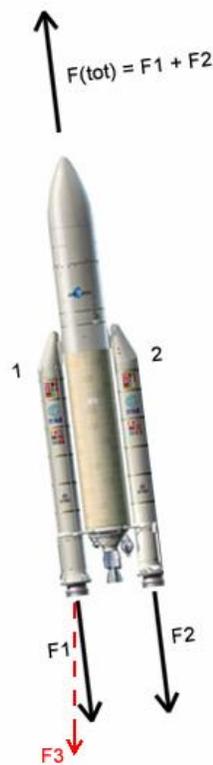
In the picture we can see the forces applied to the rocket from the solid boosters. The boosters working in parallel provide a total force  $F$  (tot) which is equal to the sum of  $F_1$  from booster 1 and  $F_2$  from booster 2.

If we have wrong boosting power from one of the boosters the total force that moves the rocket changes completely towards the direction of the movement.

The erroneous force on the frame causes the separation of the booster from the main rocket.

In result we have an alternative course and the auto distraction of the rocket is engaged.

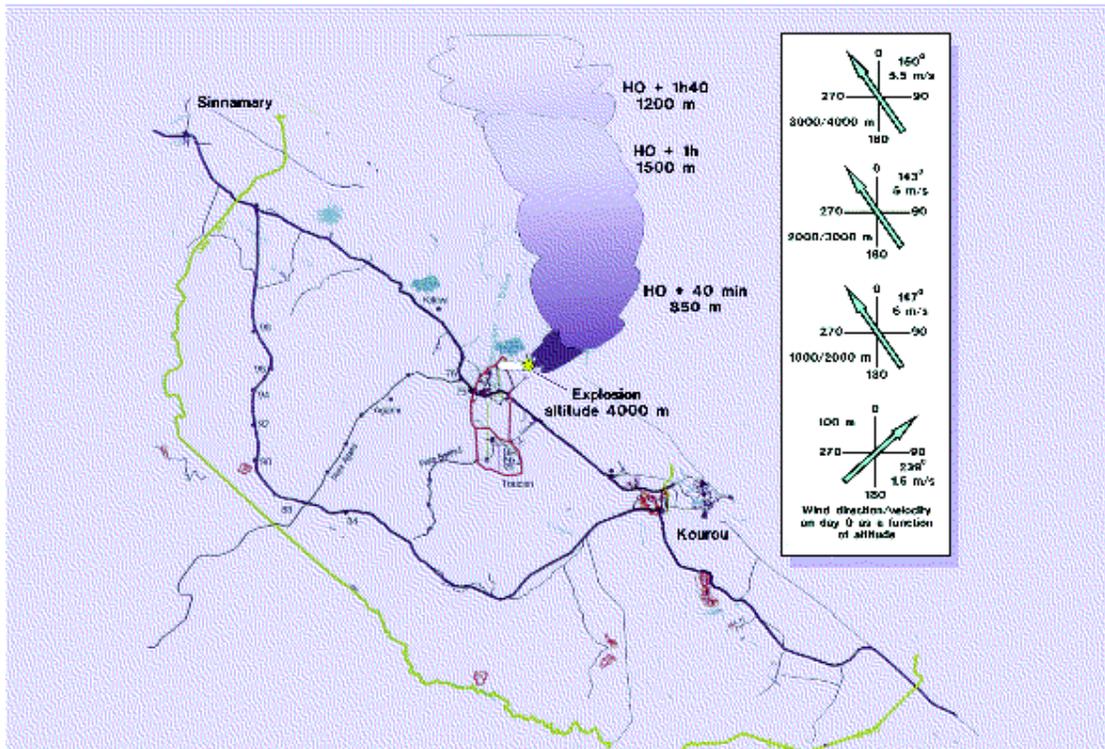
Explosion Gasses as spread in atmosphere and their spread over time (Source: CNES/CSG)

The lift – off cloud, some still burning solid – propellant fragments from the boosters and the vaporisation of the launcher were tried to be monitored at ground level also. These gases were also headed to the sea at an altitude of more than 1000m.
